STATE OF CALIFORNIA DEPARTMENT OF TRANSPORTATION DIVISION OF CONSTRUCTION OFFICE OF TRANSPORTATION LABORATORY

MOISTURE SENSORS AND THEIR PLACE IN HIGHWAY PLANTINGS

88-01

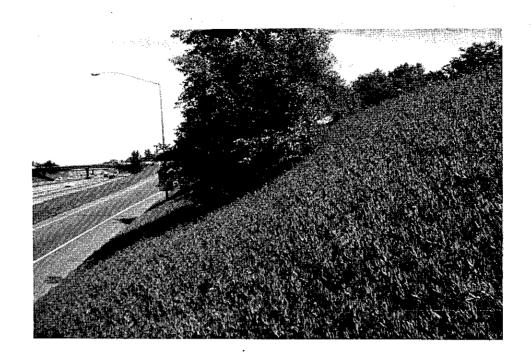
Figure 8.2
Typical View of Sacramento Site

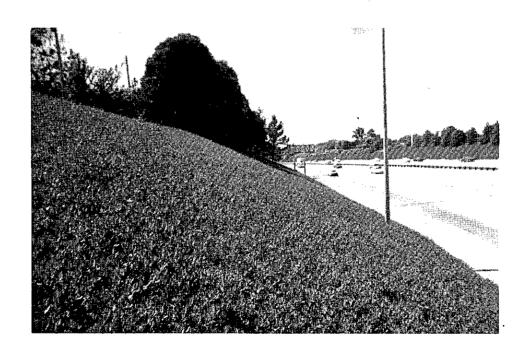
Figure 8.3
Typical View of Sacramento Site

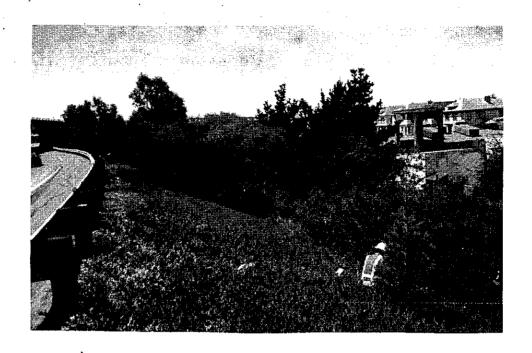
Figure 8.8
Typical View of Oakland Site
